Building Diagnostic Robotics Inspection Report

Sample Building

27th February, 2024 10:07 AM

111 ABC Street, NY, 10001

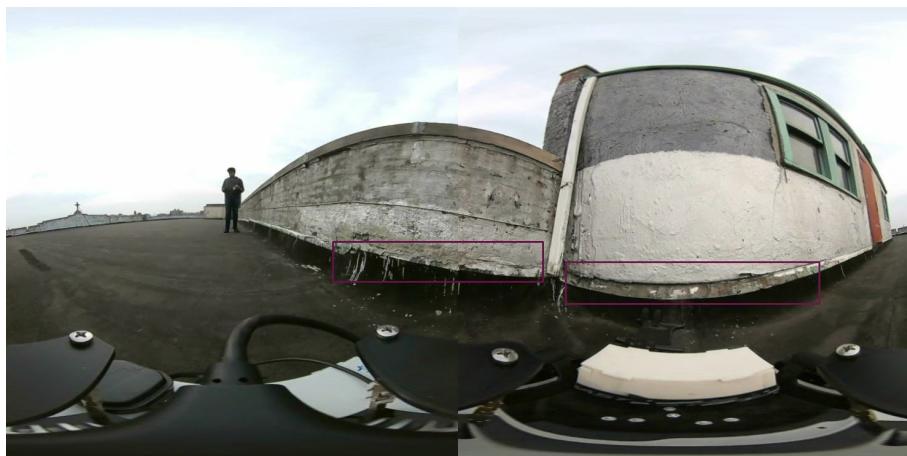
The roof inspection has identified several critical issues that require immediate attention. Base flashing made of coated metal is showing signs of wear and corrosion, which can lead to water leaks. Ponding, where water accumulates on the roof, is also a significant concern as it can weaken the structure and cause water damage.

Figure 4.1: Base Flashing-Coated Metal

These issues collectively indicate that the roof is at risk of significant water damage and structural issues. It is crucial to address these issues promptly to prevent further deterioration and ensure the roof's integrity and functionality. Immediate action is necessary to safeguard the building and prevent costly repairs in the future.

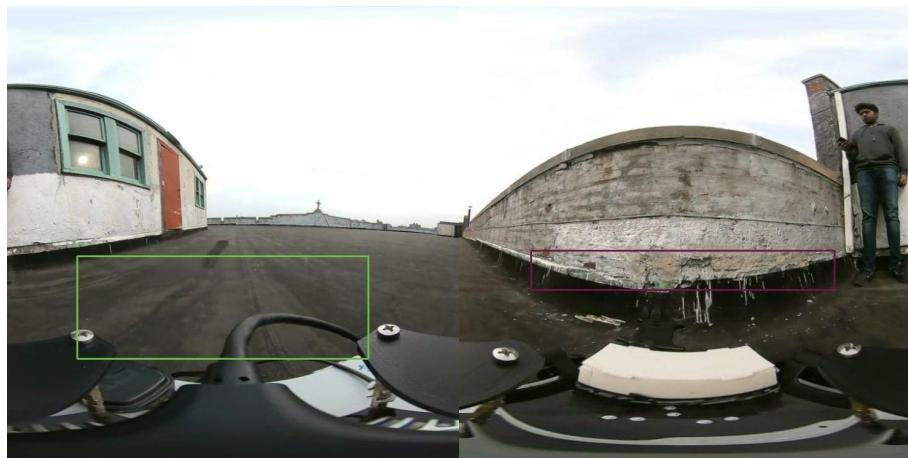
Figure 4.2: Ponding

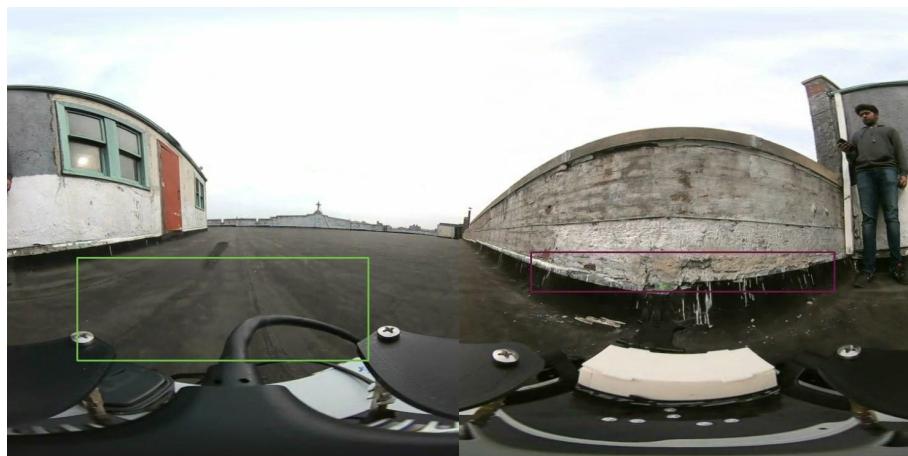
Moreover, base flashing made of membrane material is showing signs of deterioration, which could compromise its ability to keep water out. Defective seams in the roofing material pose a risk of water infiltration, further exacerbating the existing problems.

Figure 4.3: Base Flashing-Membrane Material

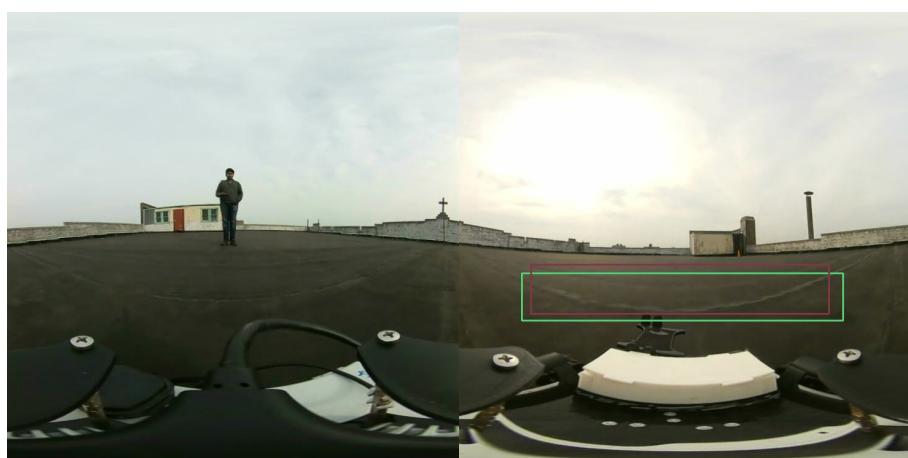
Figure 4.4: Defective Seams

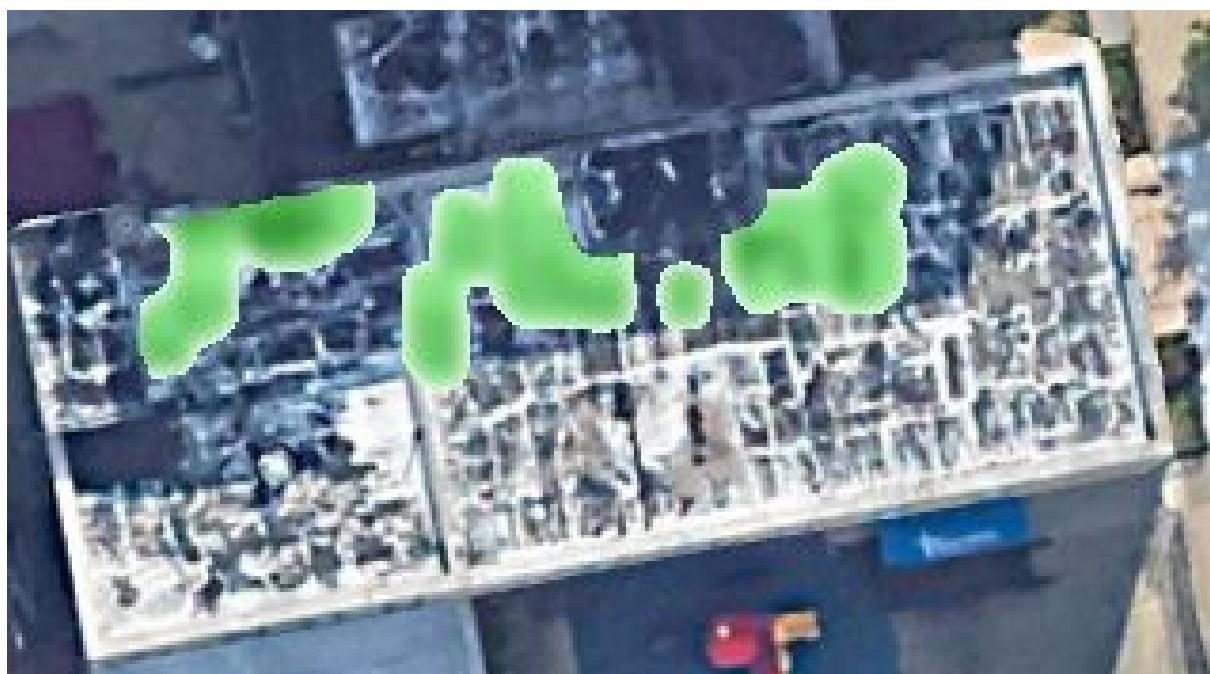
Figure 4.8: Below Membrane Moisture

The roof membrane material for this section is EPDM (Ethylene propylene dienemonomer). The underlying insulation type cannot be determined without a core-cut, but is statistically likely to be polyiso (Polyisocyanurate). A spatial analysis reveals that 19.08% of the roof is affected by sub-membrane moisture damage.

Based on a spatial analysis, 19.08% of this section is affected by sub-membrane moisture damage. These highlighted portions are considered moisture damaged and in need of repair. This presence of damaged roofing means that this section has a hazard classification of **High-Risk**. Retain a specialist roof consultant to monitor roof condition and suggest repairs to lengthen the life of your roof asset. Roof likely has between 5 and 15 years of remaining roof life. Roof life can be extended by an additional 10 to 15 years by reroofing or adding a second roofing layer. The map displayed below is based on captured and processed GPR and LiDAR data that capture different aspects of above and below membrane moisture. For reference and clarity, these maps can be found in Appendix A.

Section 1: Retain a specialist roof consultant to monitor roof condition and suggest repairs to lengthen the life of your roof asset. Roof likely has between 5 and 15 years of remaining roof life. Roof life can be extended by an additional 10 to 15 years by reroofing or adding a second roofing layer.

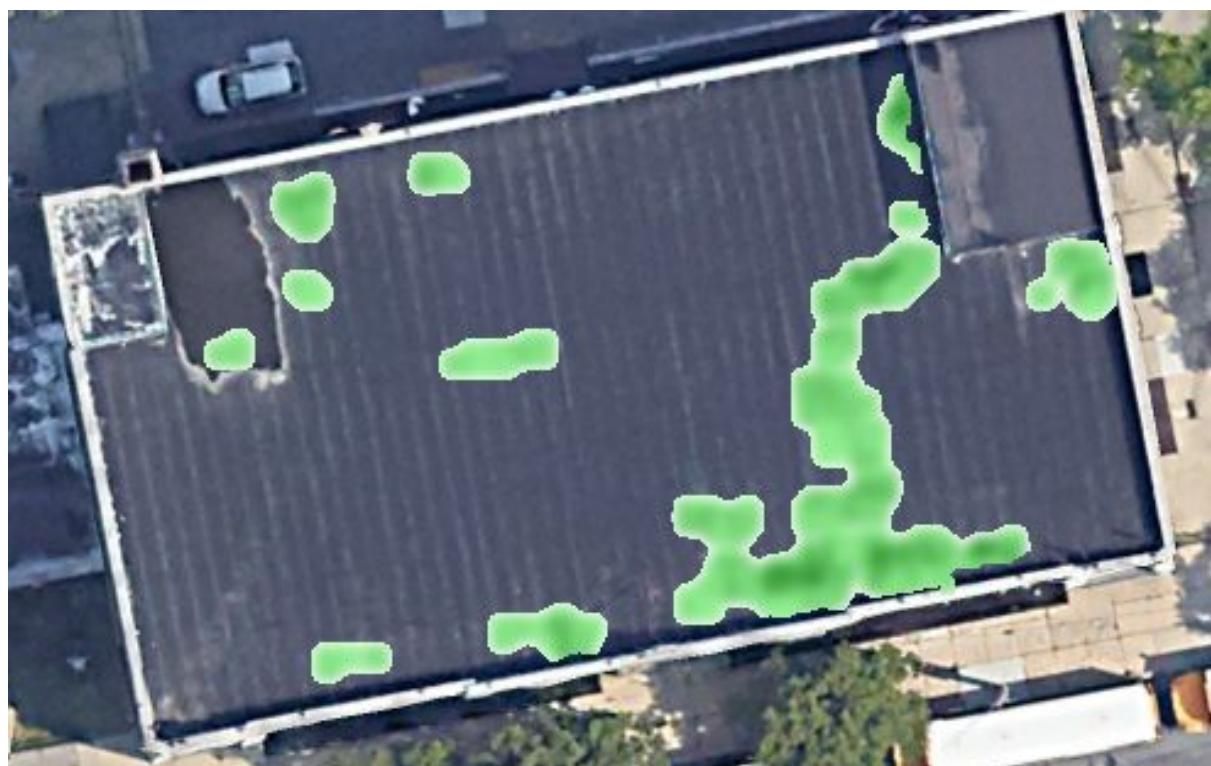
Figure 4.9: Below Membrane Moisture

The roof membrane material for this section is EPDM (Ethylene propylene dienemonomer). The underlying insulation type cannot be determined without a core-cut, but is statistically likely to be polyiso (Polyisocyanurate). A spatial analysis reveals that 15.72% of the roof is affected by sub-membrane moisture damage. The roof inspection data reveals significant concerns that demand immediate attention to preserve the integrity of the structure. The presence of base flashing made of coated metal and membrane material indicates vulnerable points where water infiltration may occur, potentially leading to water damage and mold growth. Ponding issues, characterized by standing water on the roof surface, pose a threat to the roof's structural stability and can accelerate deterioration.

Based on a spatial analysis, 15.72% of this section is affected by sub-membrane moisture damage. These highlighted portions are considered moisture damaged and in need of repair. This presence of damaged roofing means that this section has a hazard classification of **High-Risk**. Retain a specialist roof consultant to monitor roof condition and suggest repairs to lengthen the life of your roof asset. Roof likely has between 5 and 15 years of remaining roof life. Roof life can be extended by an additional 10 to 15 years by reroofing or adding a second roofing layer. The map displayed below is based on captured and processed GPR and LiDAR data that capture different aspects of above and below membrane moisture. For reference and clarity, these maps can be found in Appendix A.

Section 2: Retain a specialist roof consultant to monitor roof condition and suggest repairs to lengthen the life of your roof asset. Roof likely has between 5 and 15 years of remaining roof life. Roof life can be extended by an additional 10 to 15 years by reroofing or adding a second roofing layer.

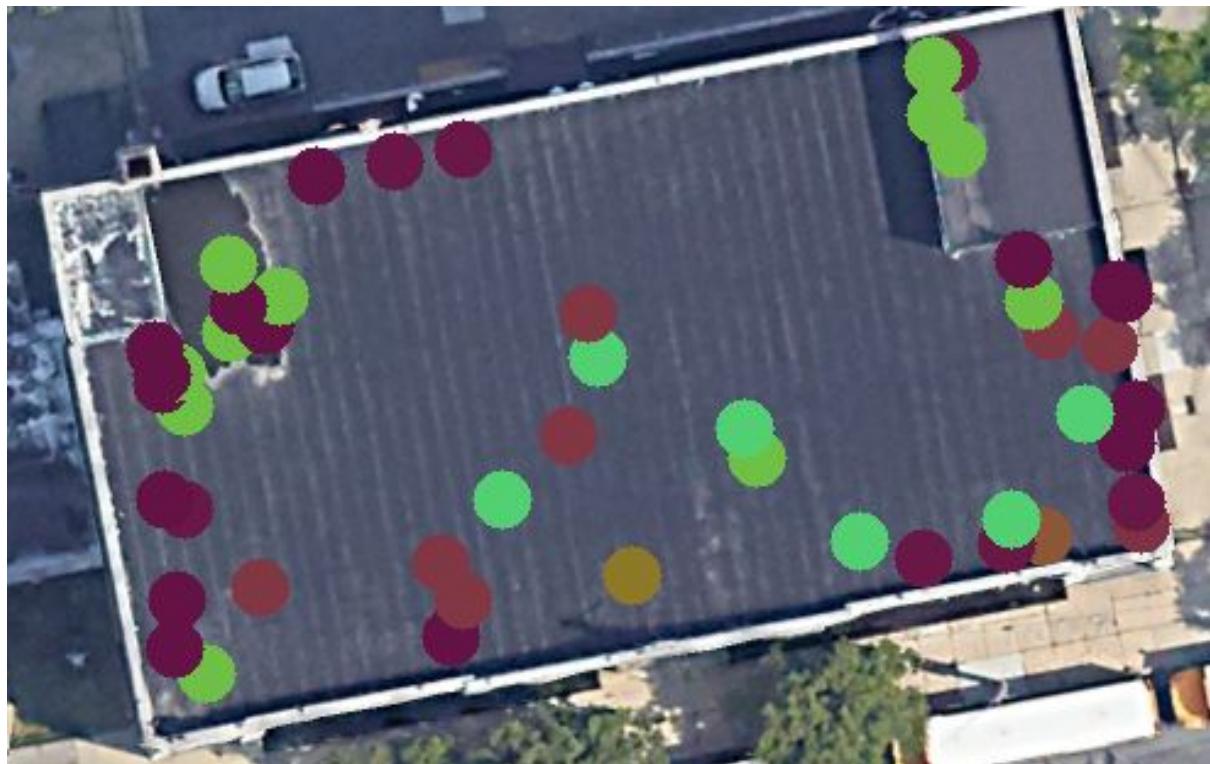
Figure 4.10: Visual Image

Defective seams across the roofing components are clear indicators of wear and tear, increasing the risk of leaks and compromising the entire roofing system's effectiveness. Addressing these issues promptly is crucial to prevent further damage to the property and ensure the roof's longevity.

The inspection identified multiple visual defects, as illustrated in the map below which depicts the distribution of membrane defects. The subsequent table details the specific types of defects and their observed frequencies within this section, providing a clear overview of the roof's condition. Photographic records of these issues and conditions can be found in Appendix B.

Color	Defect Type	Count
	Base Flashing-Membrane Material	12
	Flashed Penetrations	3
	Debris And Vegetation	2
	Base Flashing-Coated Metal	21
	Ponding	15
	Interior Drains And Roof Level Scuppers	1
	Splits	1
	Defective Seams	10
	Improper Equipment Supports	1
	Ridges	9
	Membrane Support Deficiencies	1

To safeguard the building and its occupants, it is essential to prioritize repairs and maintenance to address these identified roofing issues efficiently. By taking proactive measures now, you can mitigate the risk of costly repairs and potential safety hazards in the future.
