Building Diagnostic Robotics Inspection Report

Sample Building

27th February, 2024 10:07 AM

111 ABC Street, NY, 10001

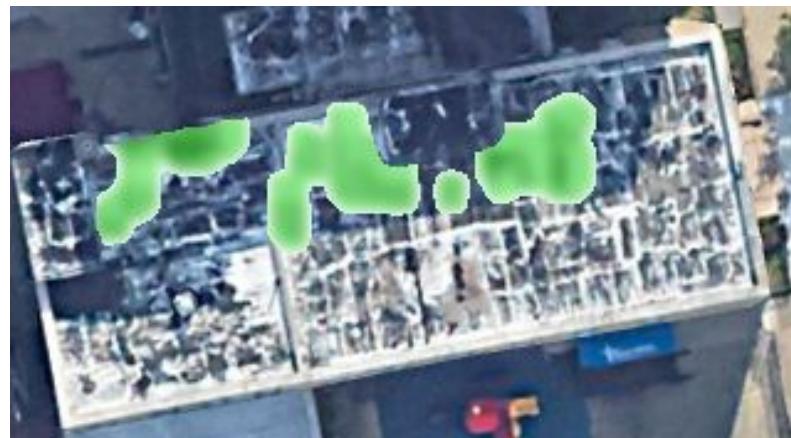
Figure 2.1: GPR-Captured Moisture Map

Section Number	Moisture Percent	Risk Level	Square Footage	Area Damaged
1	19.08%	High-Risk	3080 sq.ft.	587 sq.ft.
2	15.72%	High-Risk	9160 sq.ft.	1439 sq.ft.

Section 1: Retain a specialist roof consultant to monitor roof condition and suggest repairs to lengthen the life of your roof asset. Roof likely has between 5 and 15 years of remaining roof life. Roof life can be extended by an additional 10 to 15 years by reroofing or adding a second roofing layer.

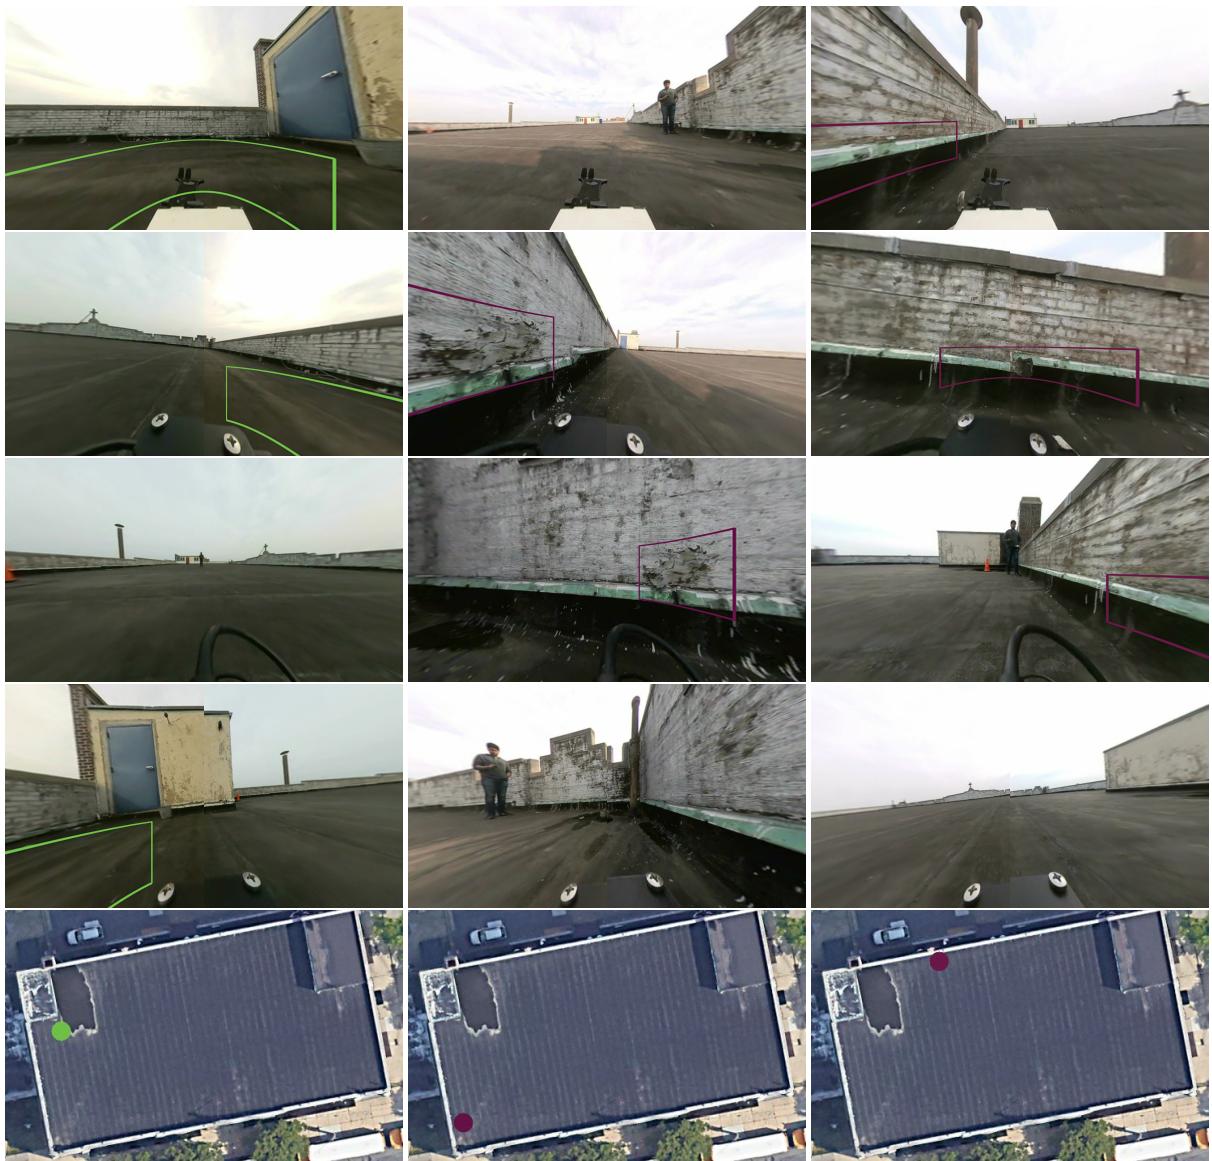
Location - 7
Ponding

Location - 8
Base Flashing-Coated Metal

Location - 9
Base Flashing-Membrane
Material

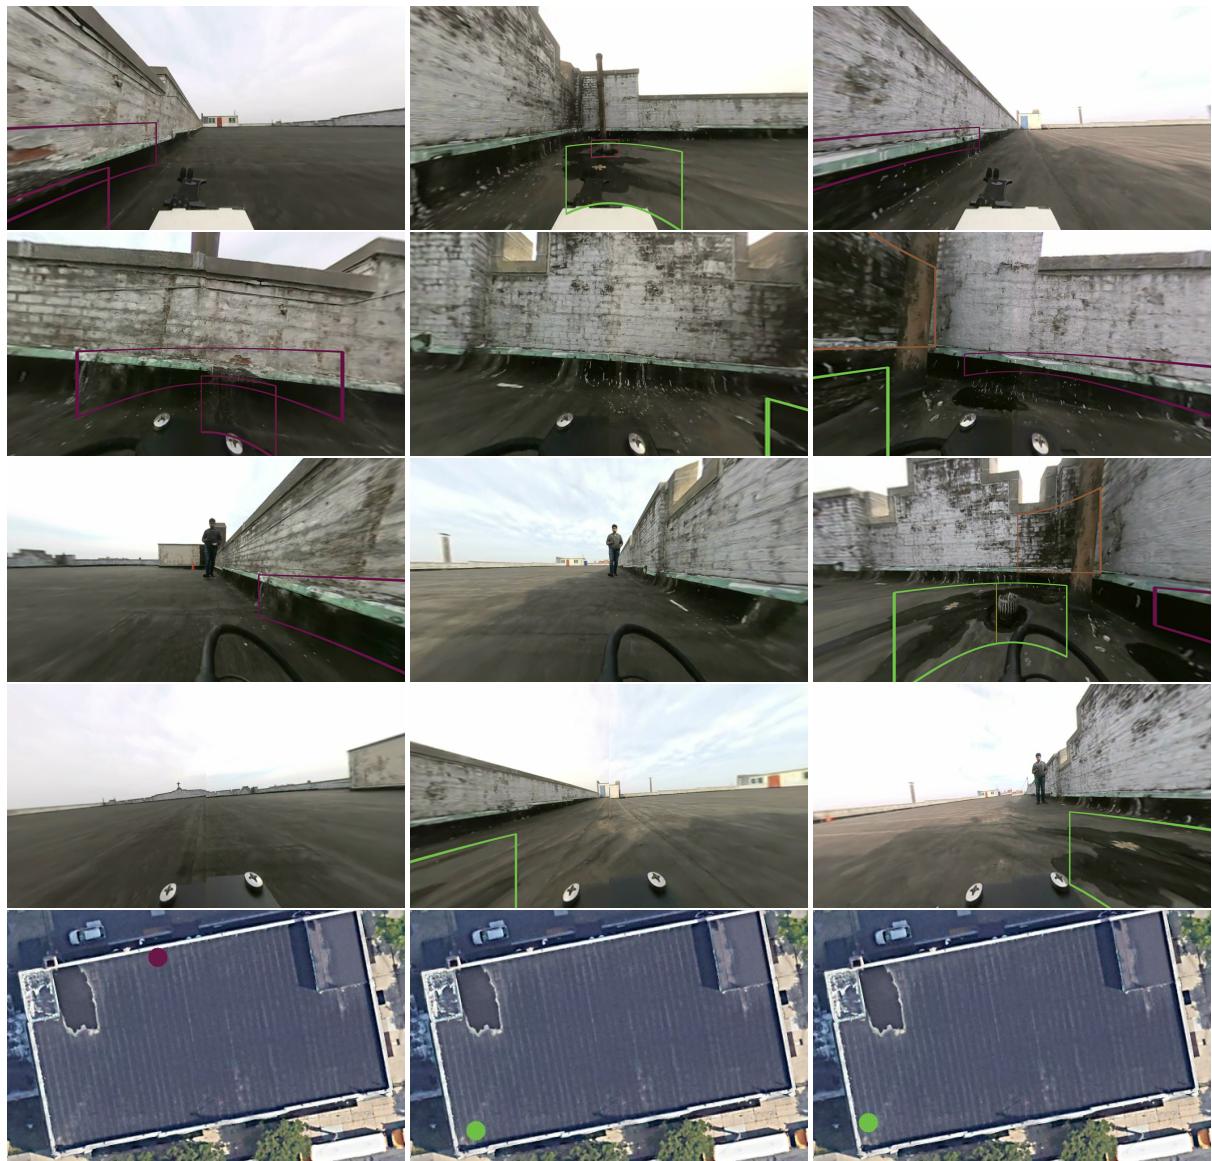
Location - 13

Base Flashing-Coated Metal
Base Flashing-Membrane
Material

Location - 14

Debris And Vegetation
Ponding

Location - 15

Ponding
Base Flashing-Coated Metal
Flashed Penetrations
Interior Drains And Roof Level
Scuppers

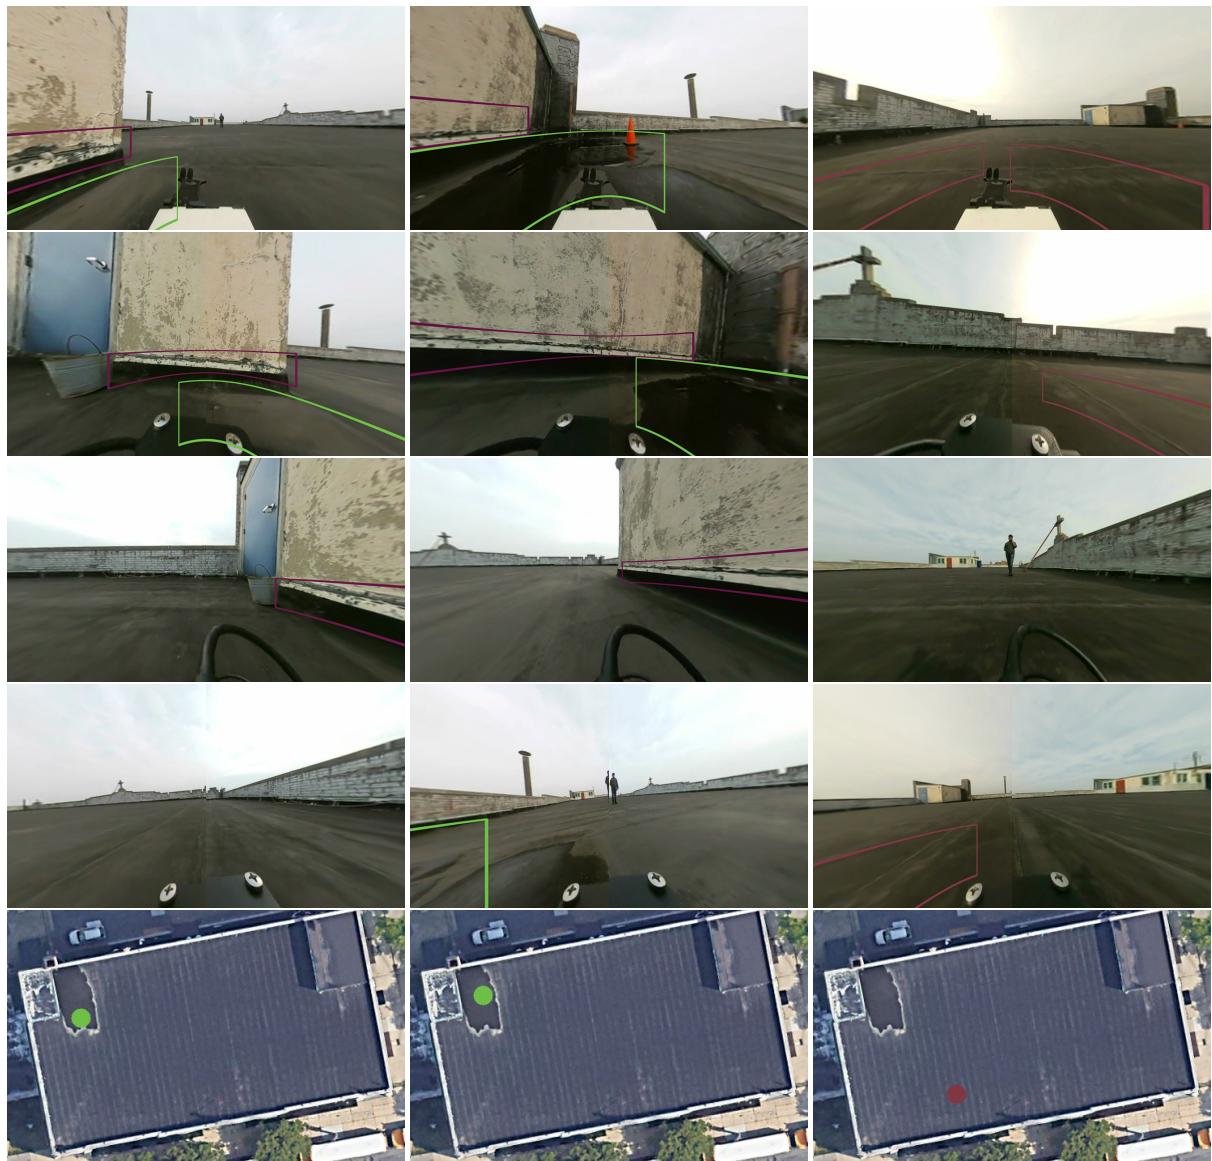
Location - 16

Ponding
Base Flashing-Membrane
Material

Location - 17

Base Flashing-Coated Metal
Ponding

Location - 18

Defective Seams

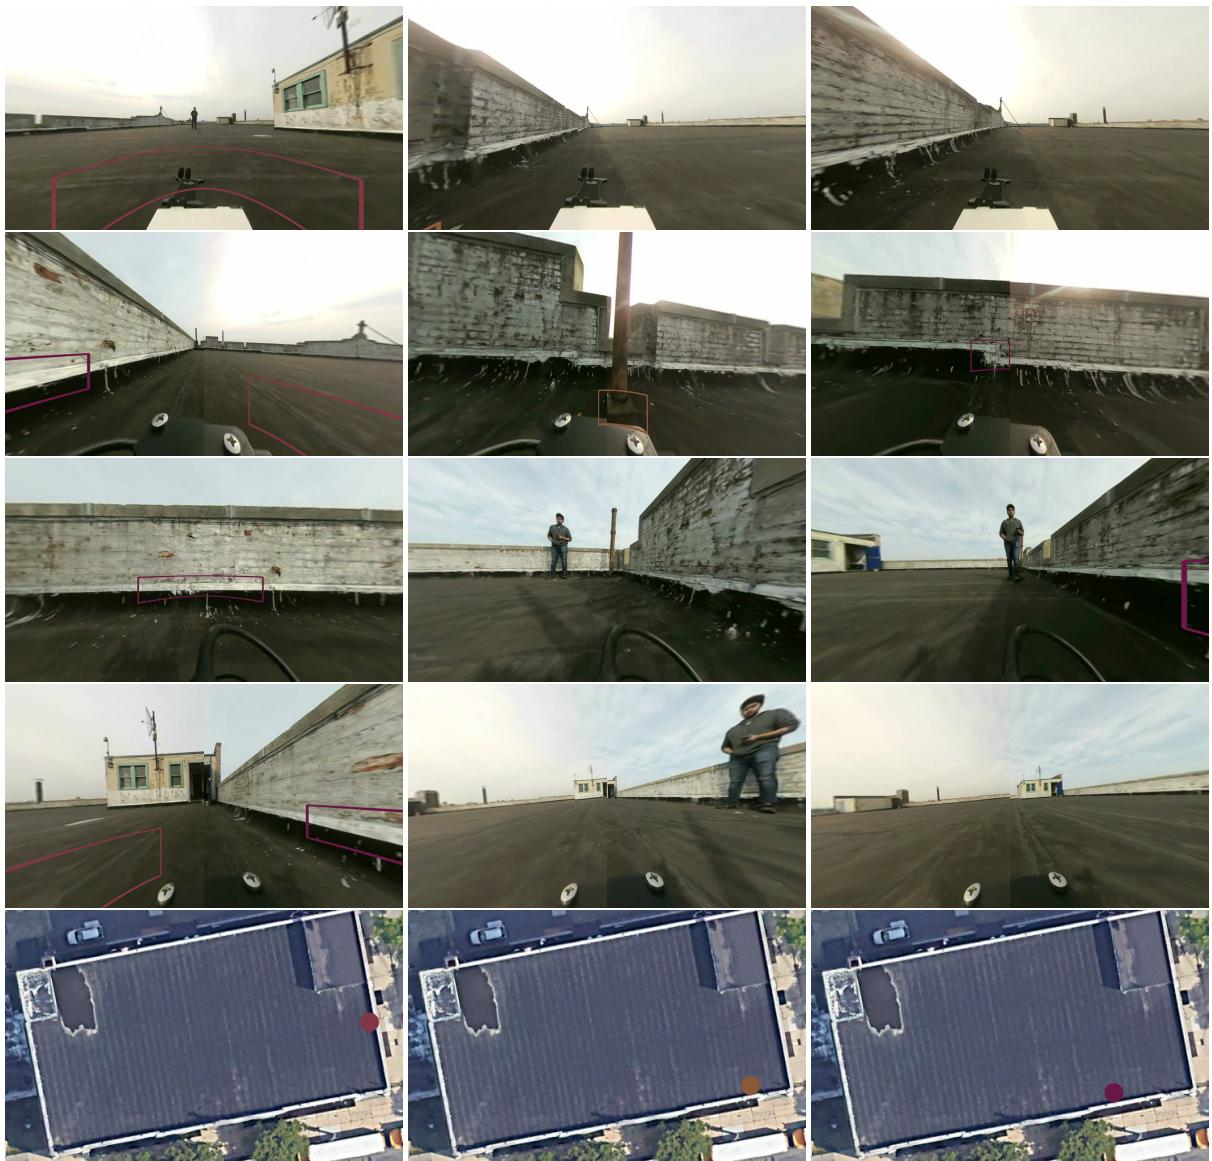
Location - 25

Defective Seams
Base Flashing-Membrane
Material

Location - 26

Flashed Penetrations

Location - 27

Base Flashing-Membrane
Material

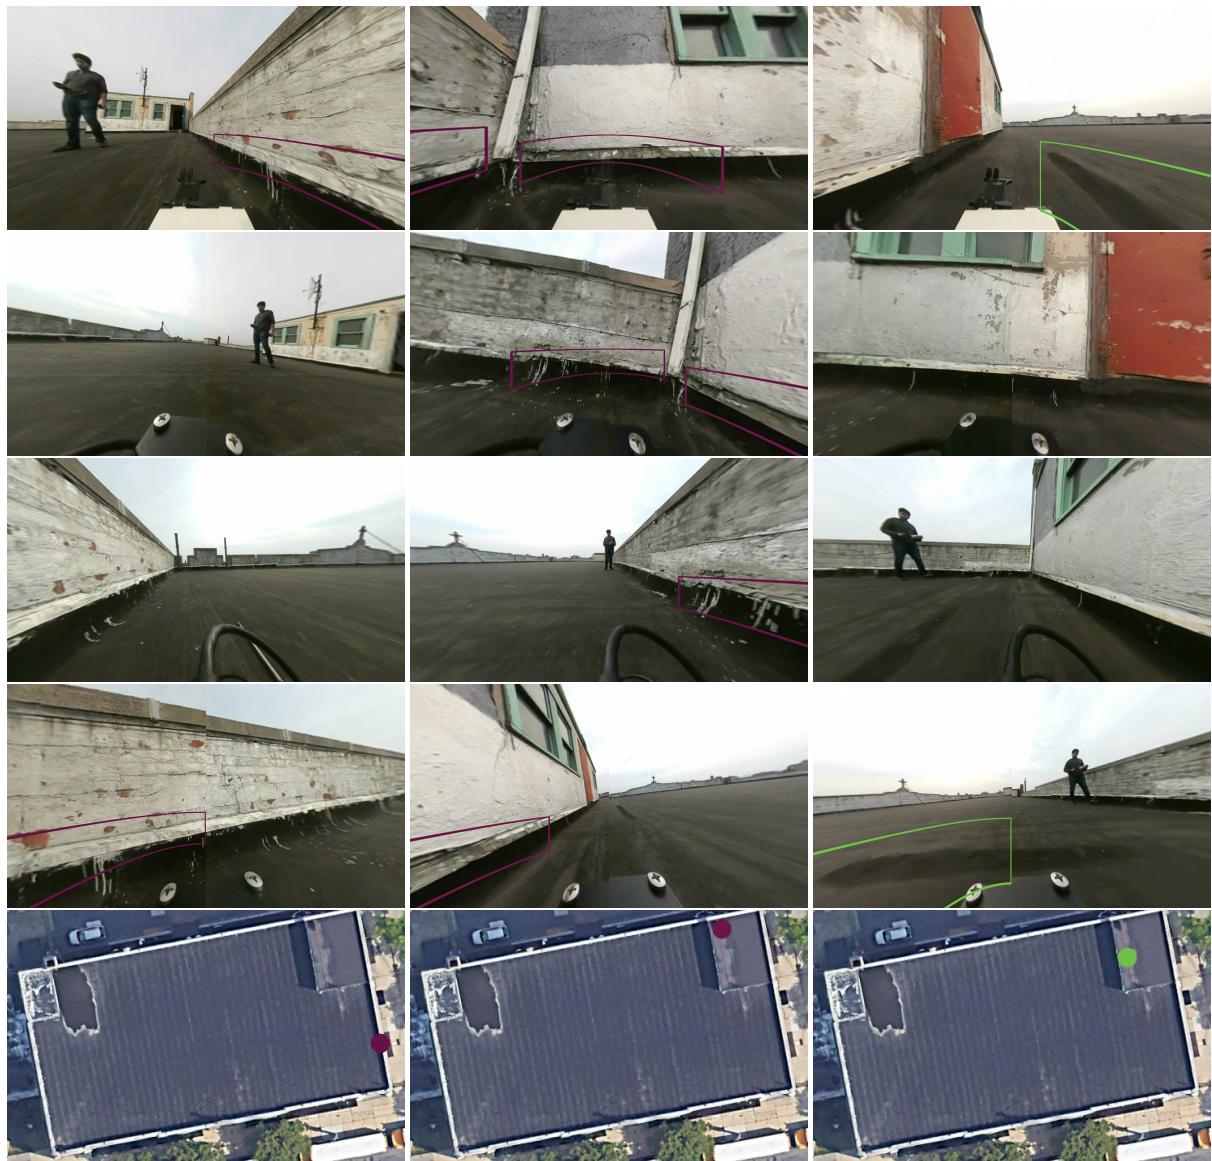
Location - 29

Base Flashing-Coated Metal

Base Flashing-Membrane

Material

Location - 28

Location - 30

Ponding

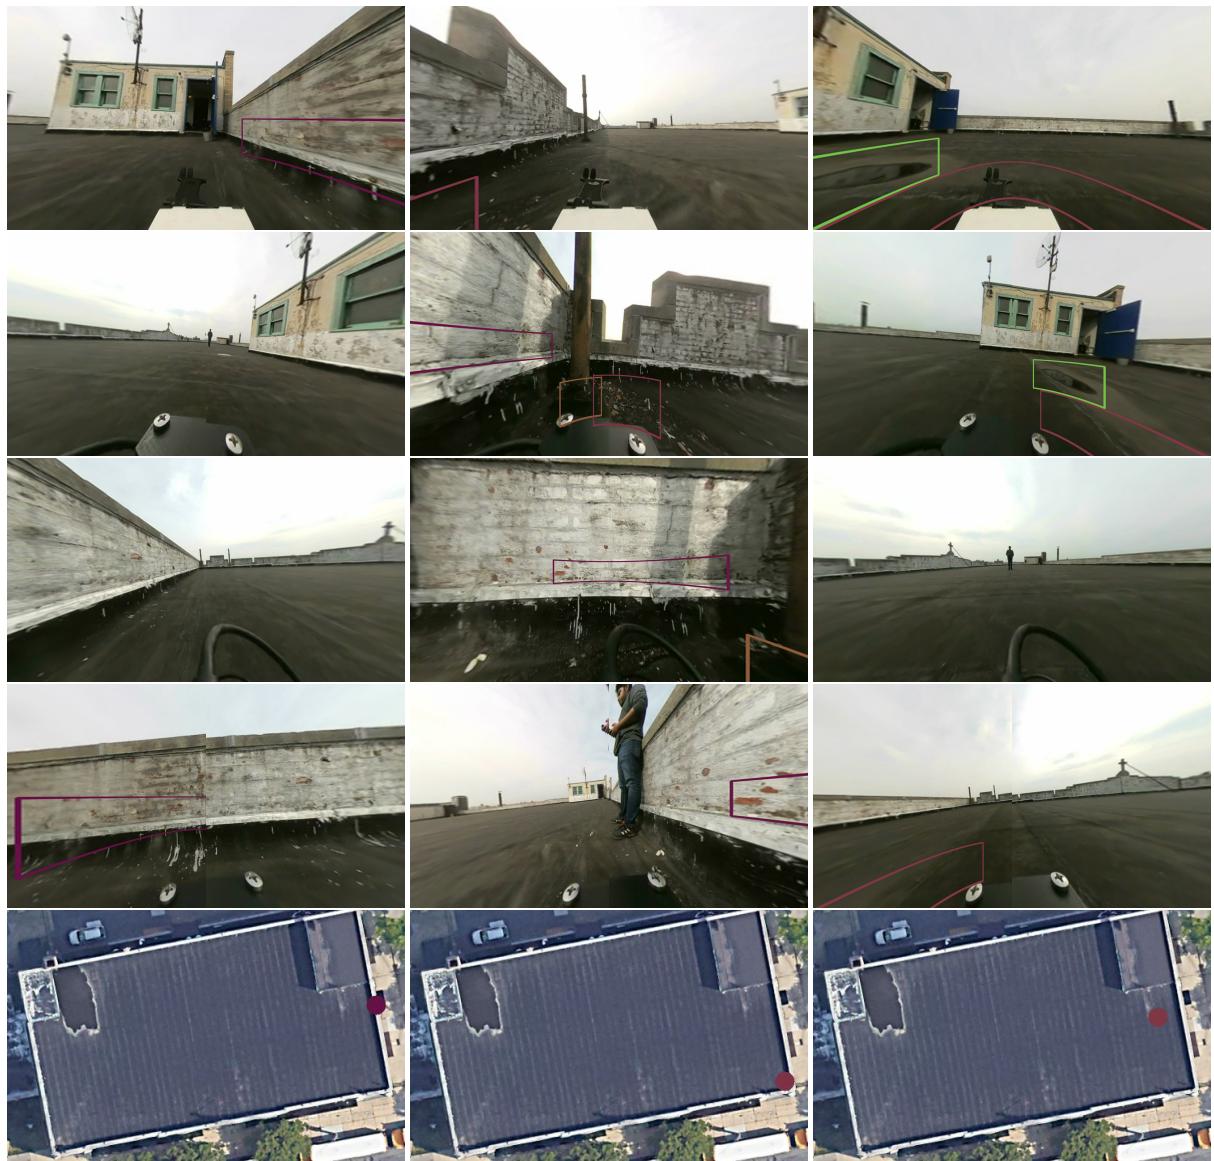
Location - 32

Debris And Vegetation

Flushed Penetrations

Base Flashing-Membrane

Material

Location - 33

Defective Seams

Ponding

Location - 31

Base Flashing-Coated Metal

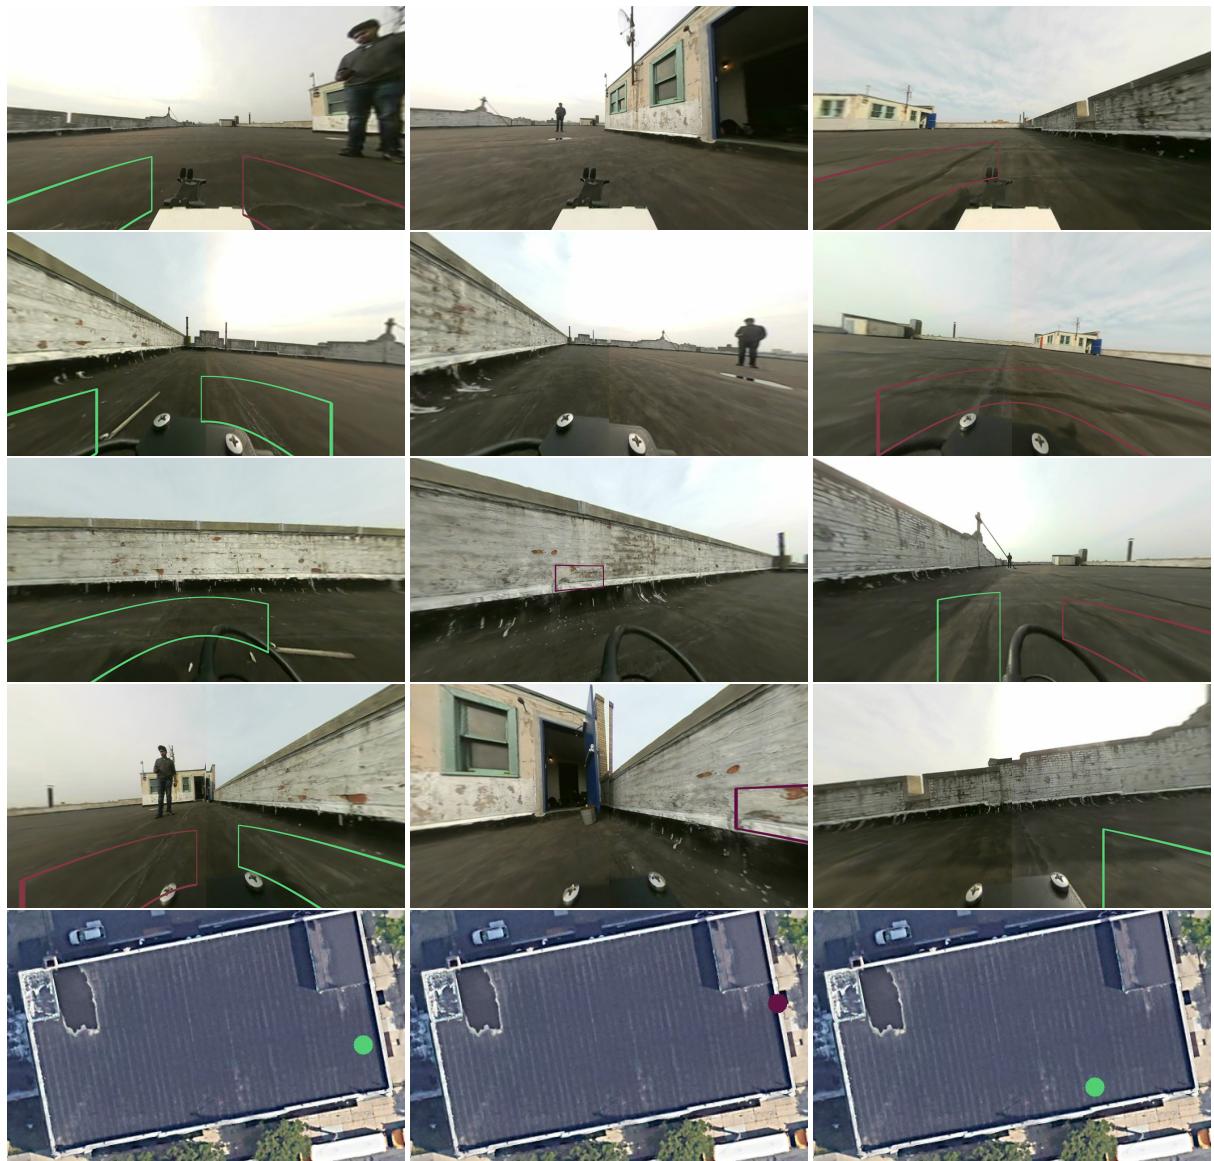
Location - 34

Defective Seams
Ridges

Location - 35

Base Flashing-Coated Metal

Location - 36

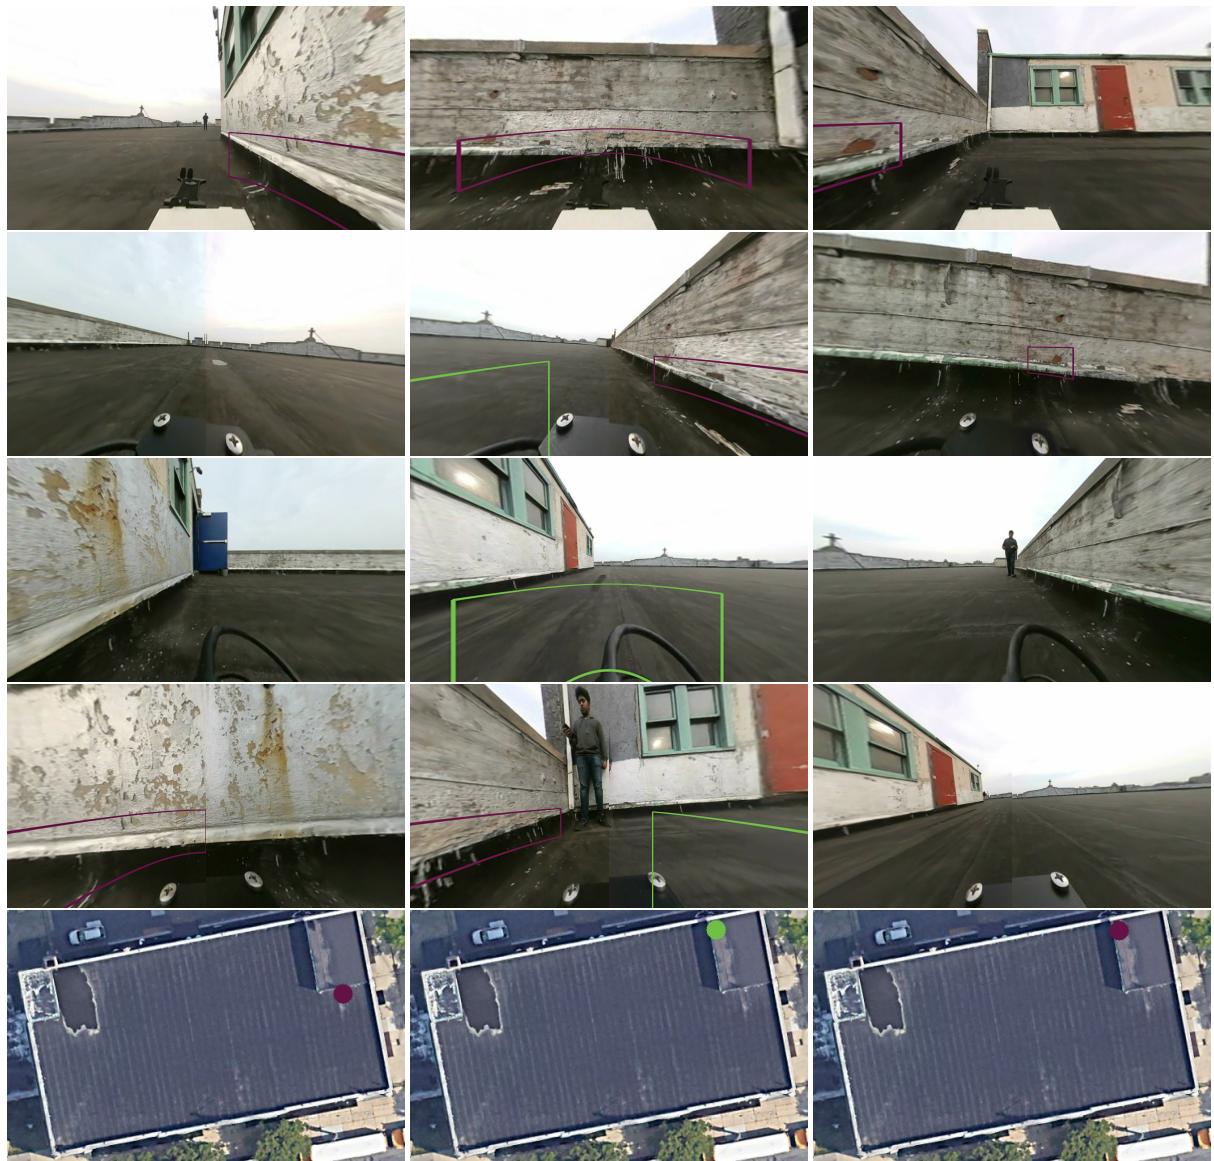
Location - 37
Base Flashing-Coated Metal

Location - 38
Ponding
Base Flashing-Membrane
Material

Location - 39
Base Flashing-Coated Metal

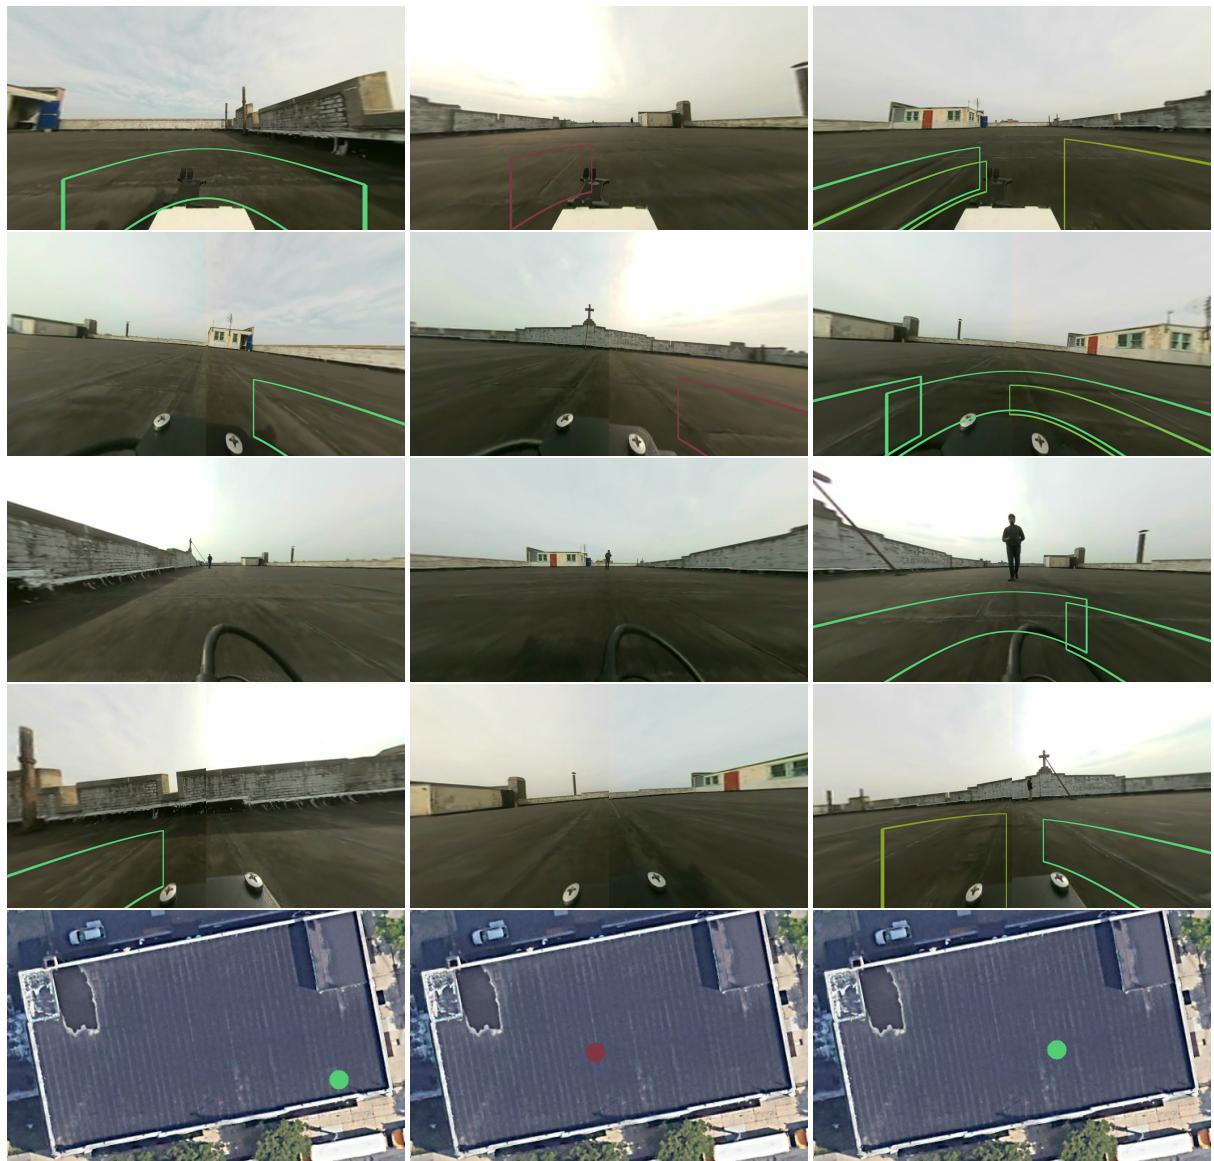
Location - 43
Ridges

Location - 44
Defective Seams

Location - 45
Ridges
Ponding
Membrane Support
Deficiencies

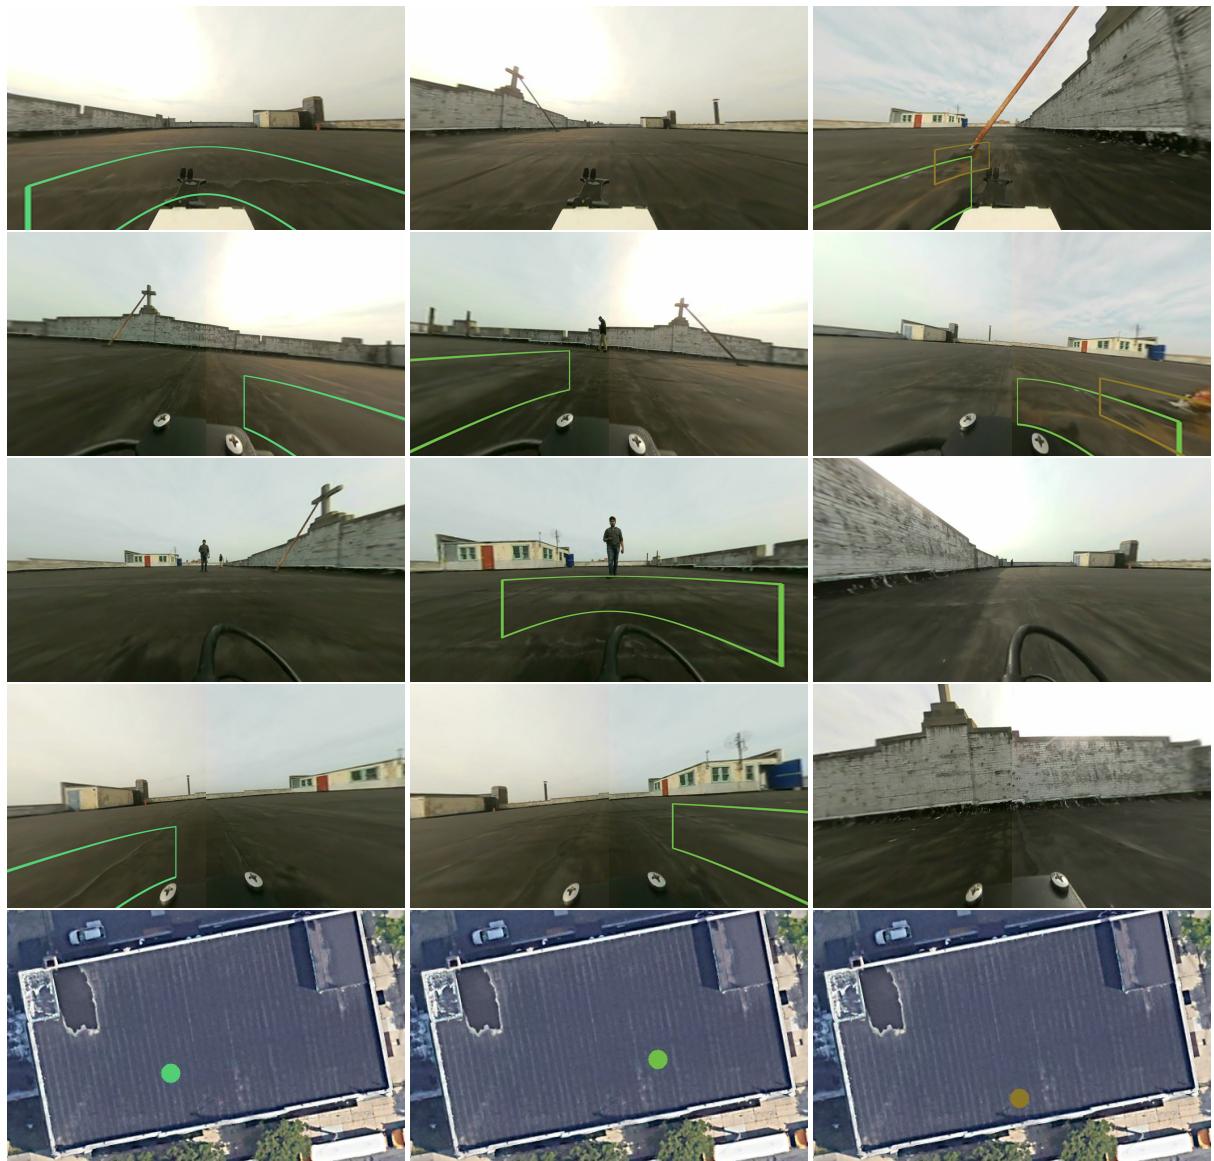
Location - 46
Ridges

Location - 47
Ponding

Location - 48
Improper Equipment Supports
Ponding

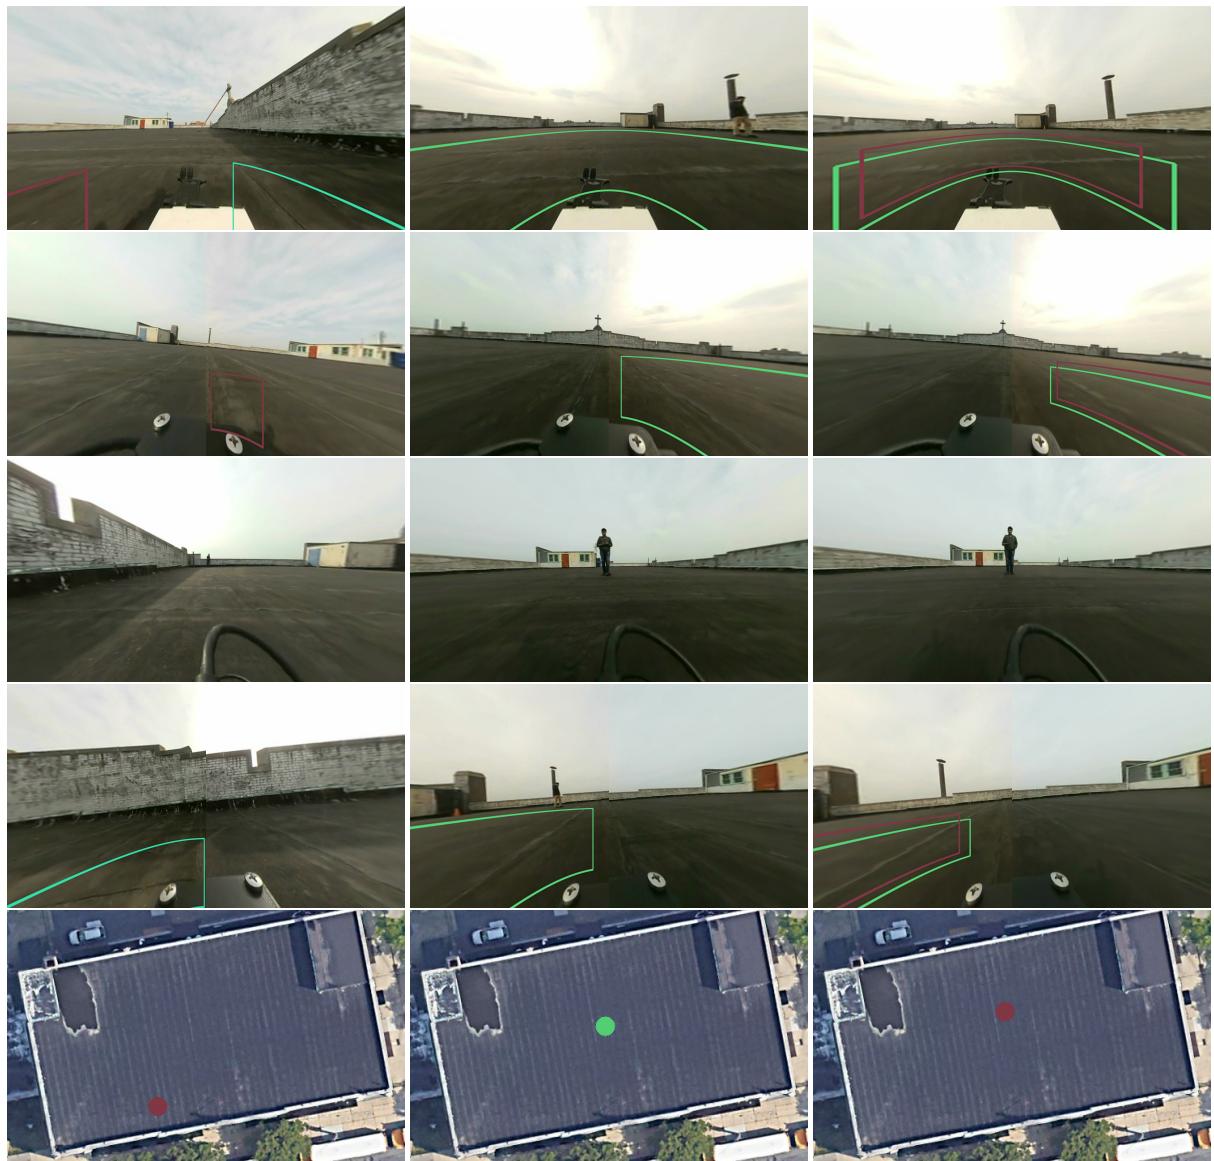
Location - 49

Defective Seams

Splits

Location - 50

Ridges

Location - 51

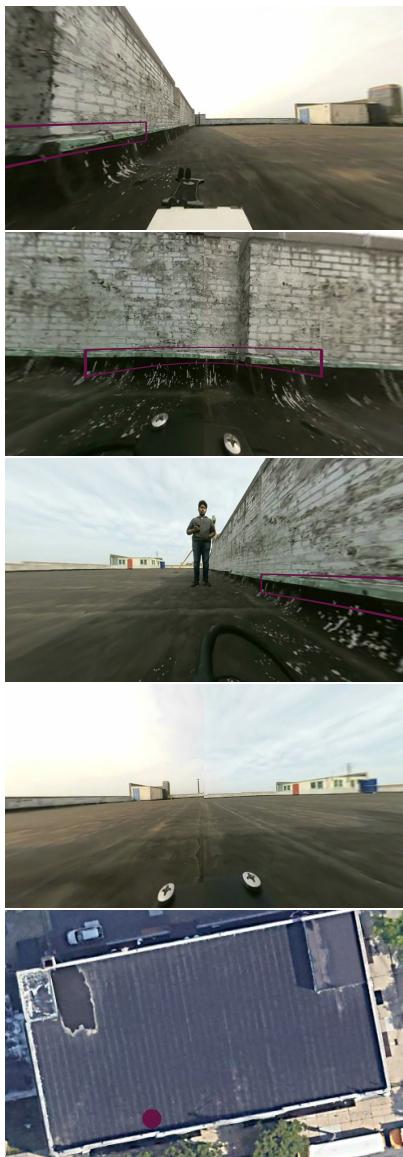
Location - 52
Base Flashing-Coated Metal
