Building Diagnostic Robotics Inspection Report

Sample Building

27th February, 2024 10:07 AM

111 ABC Street, NY, 10001

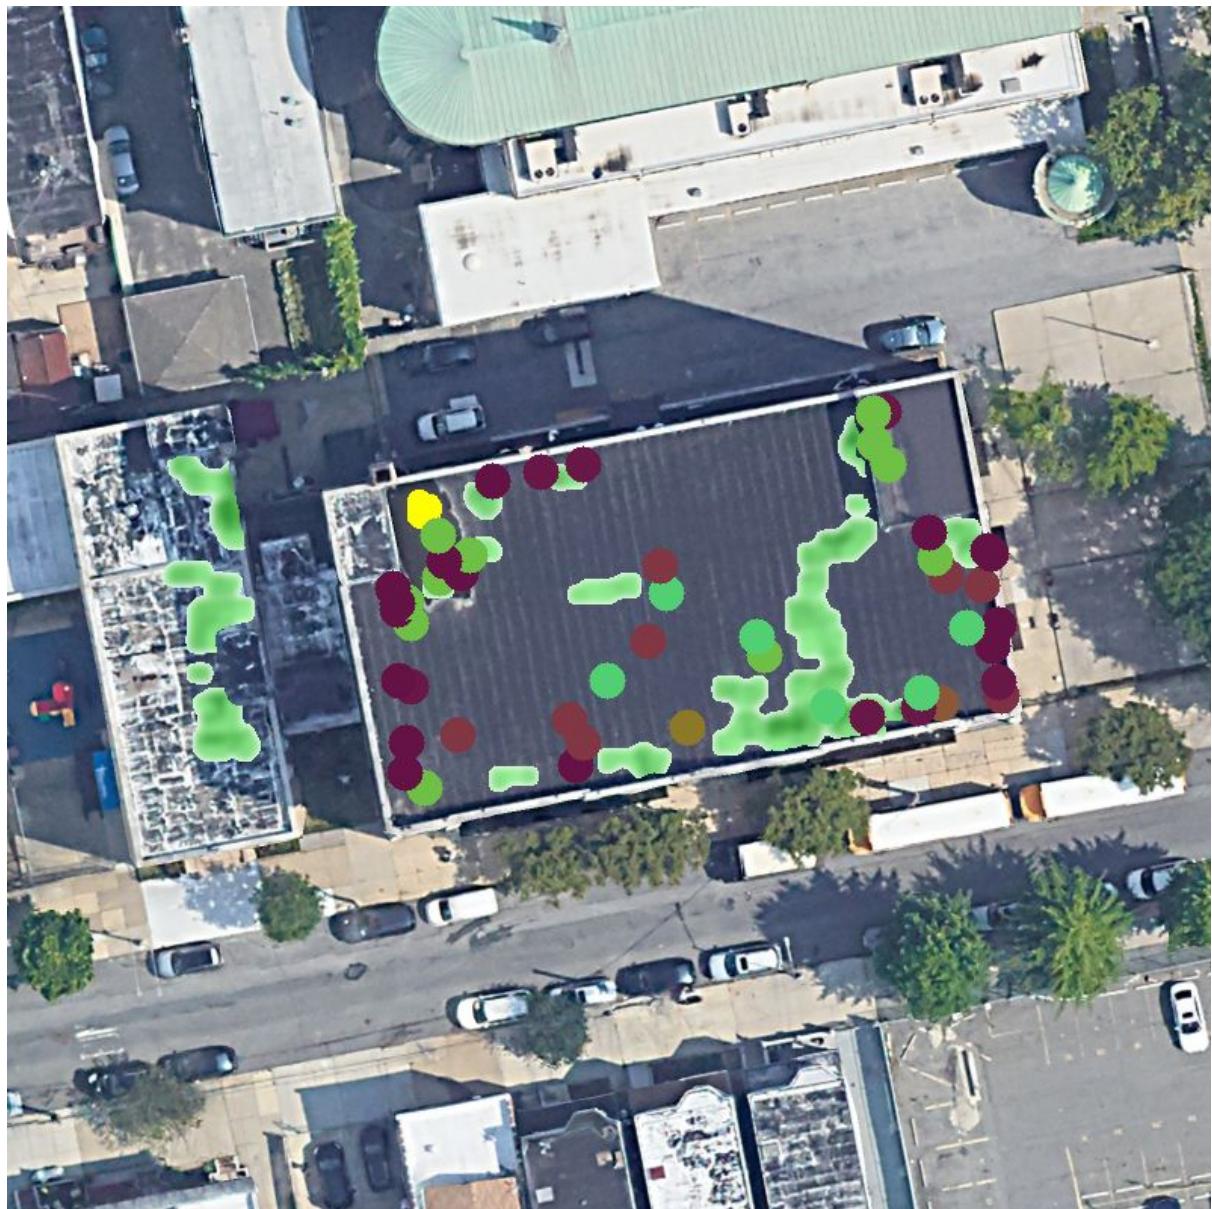
Figure 4.5: All Observed Deficiencies Map

This map consolidates all detected issues into a single visual representation, streamlining the dissemination and interpretation of information. Please refer to the sectional maps on the following pages for more detailed and granular discussions of the issues noted here.

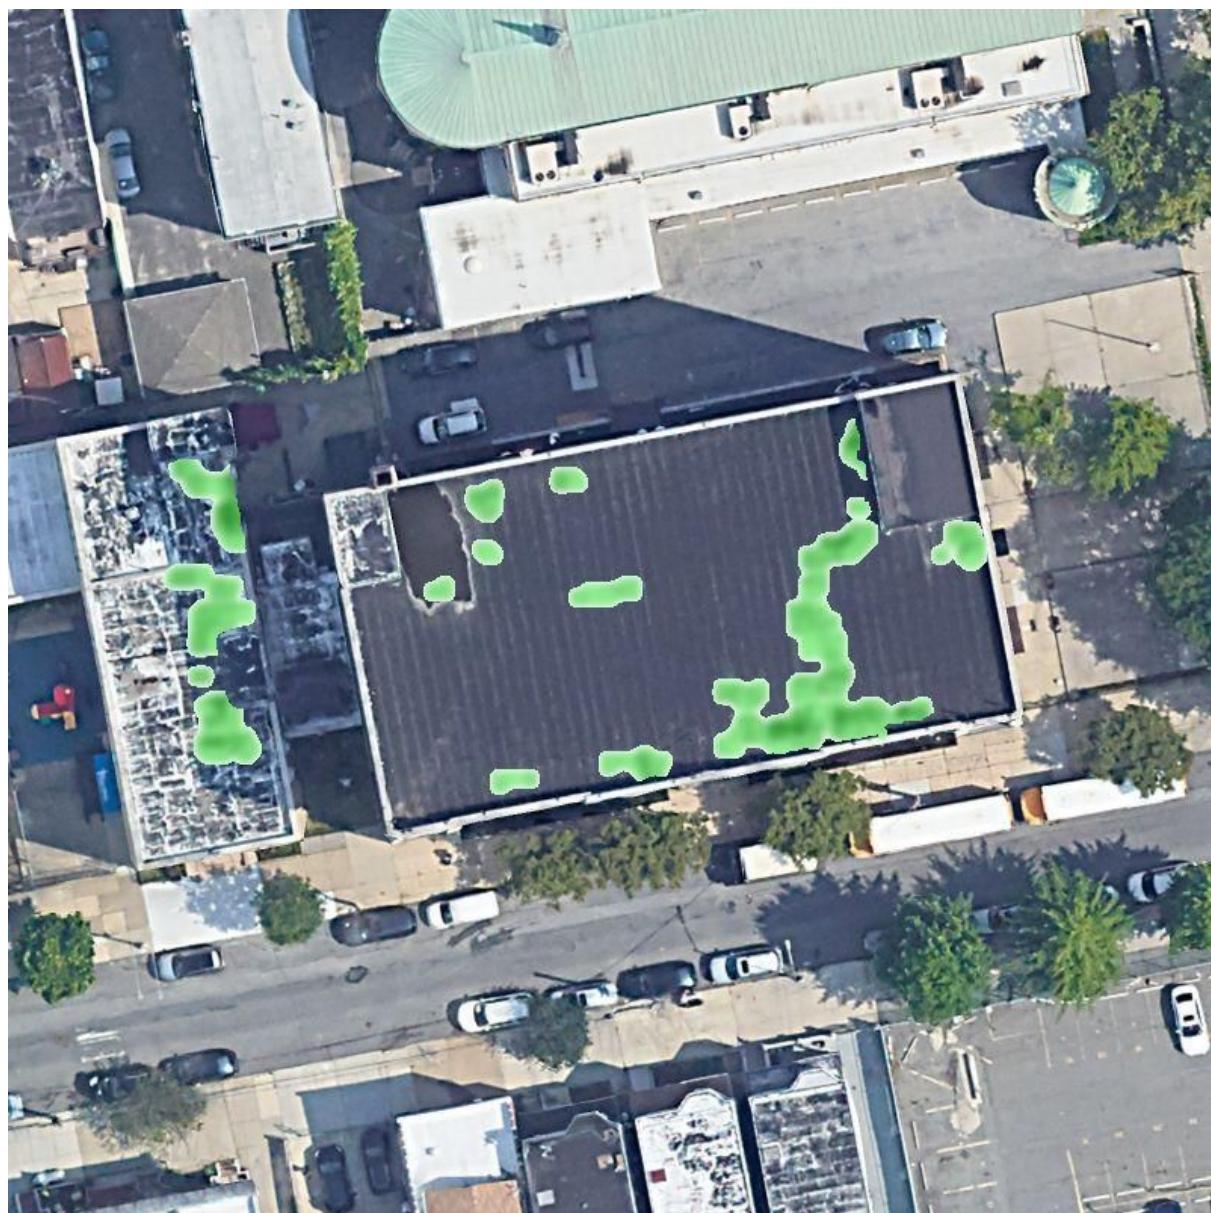
Figure 4.6: Below Membrane Moisture Map

This map shows the below membrane moisture map for the roof across the entire complex. This provides an overview to illustrate the overall condition of the roofs in this complex.
