# Building Diagnostic Robotics Inspection Report

Sample Building

<b>1</b>	<b>Executive Summary</b>	<b>2</b>
<b>2</b>	<b>Roofer Analysis Cost Estimation</b>	<b>3</b>
<b>3</b>	<b>Section - 2</b>	<b>4</b>
3.1	Section - 2 Overview . . . . .	4

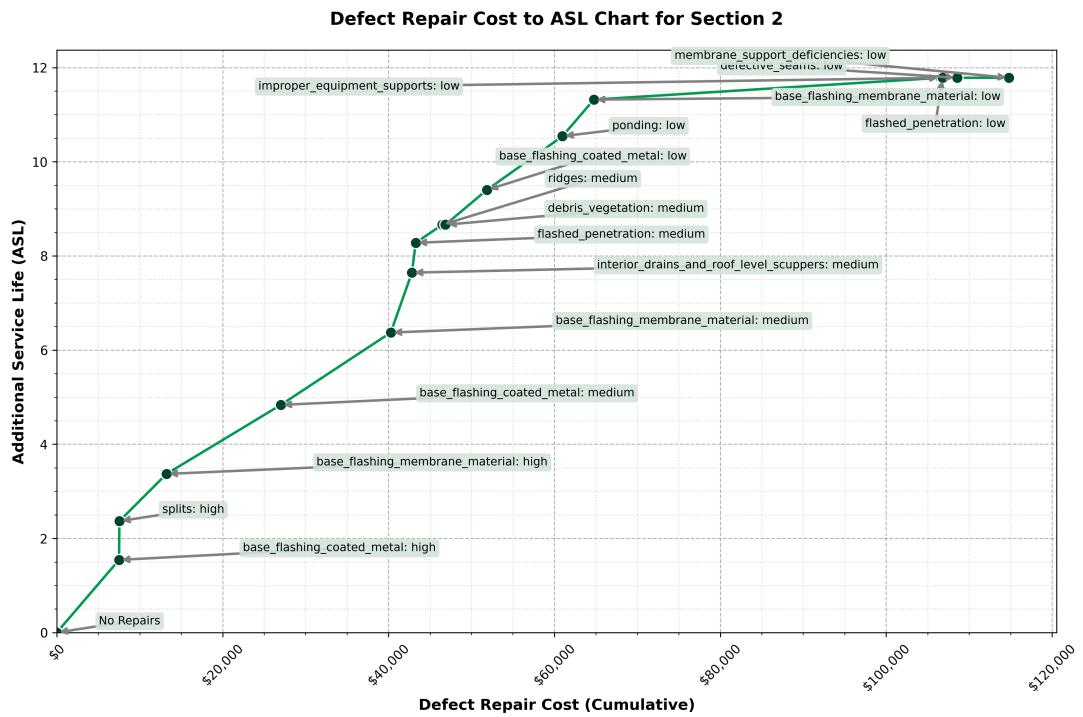
**Understanding the Chart:** Each point on the line represents a repair scenario, starting from the baseline condition (no repairs) and progressively adding fixes for identified defects. The horizontal axis shows the cumulative cost of repairs, while the vertical axis indicates the additional service life gained in years. This visualization helps you identify the most cost-effective repair strategies for maximizing your roof's lifespan.

Figure 3.1: Cost to Additional Service Life Analysis for Section 2

To help you make informed decisions about roof repairs and capital planning, we have prepared a cost-benefit analysis that shows how different repair strategies impact the roof's service life. The chart below illustrates the relationship between repair costs and the additional years of service life you can expect from your roof.
